# Manhole Inspection Summary

Manhole # S250\_\_012MH

Insp Date: **4/2/08 12:16 PM**

**Location** Address: **1403 Ward St**

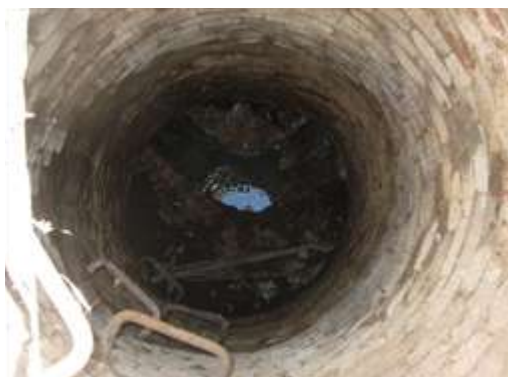
Defect 3

Condition: ☐ Sound ☐ Cracked ☐ Root Intrusion ☐ Deteriorated ☐ Leaks ☒ **Debris**

Channel Debris

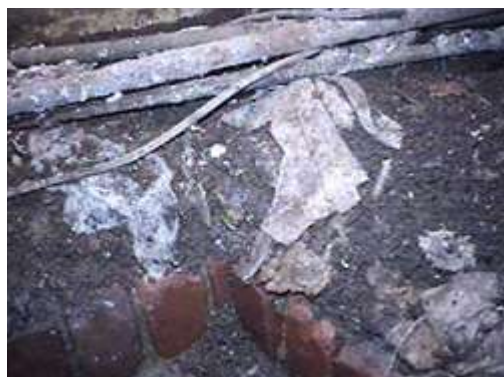
Defect 1

Condition: ☐ Sound ☐ Cracked ☐ Root Intrusion ☐ Deteriorated ☐ Leaks ☒ **Debris**

Debris and sediment on bench

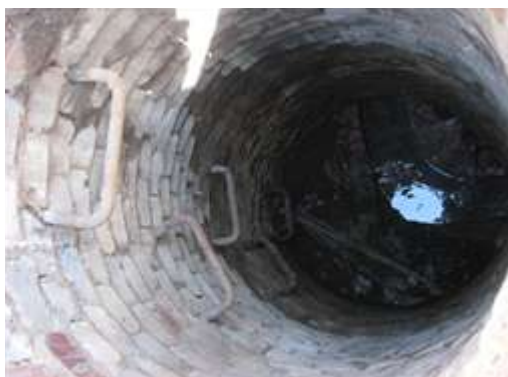
Defect 2

**Steps** Count: **4** Missing: **0** ☒ **Corroded**

Corroded steps

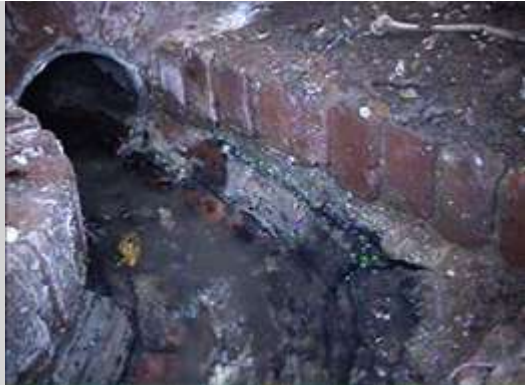
12 O'Clock Outflow

Pipe Height: **8.4** (in.) Rod and Bar (Angled)  
Pipe Material: **Clay** ☐ Pipe Lined  
Invert Depth: **10.10** (ft.) Flow Characteristics: **Slow**  
Deposits: ☒ None ☐ Mud ☐ Sludge ☐ Debris ☐ Grease  
Silt Depth: **0** (in.) Deposits Extent:  
Infiltration: **None** Pipe Seal Cond: **Sound**

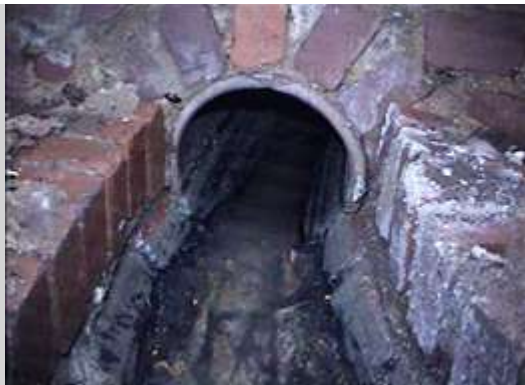
9 O'Clock Inflow

Pipe Height: **8.4** (in.) Rod and Bar (Angled)  
Pipe Material: **Clay** ☐ Pipe Lined  
Invert Depth: **12.40** (ft.) Flow Characteristics: **Slow**  
Deposits: ☒ None ☐ Mud ☐ Sludge ☐ Debris ☐ Grease  
Silt Depth: **0** (in.) Deposits Extent:  
Infiltration: **None** Pipe Seal Cond: **Sound**
